# MANLE LANDSLIDES, PITHORAGARH, UTTARAKHAND- A CASE STUDY

\*R. A. Singh

At the H P Bend near Manle Market the rainfall-induced landslides occur resulting in damaging of the newly constructed road and house nearby the road. The study tells that joints and bedding planes of the slates helps for the infiltration of water which increased pore water pressure and seepage forces and caused landslides. The slope failure is rock slips and debris slides. An attempt has also been made how to take preventive measures for landslides during reconstruction of the road at this place.

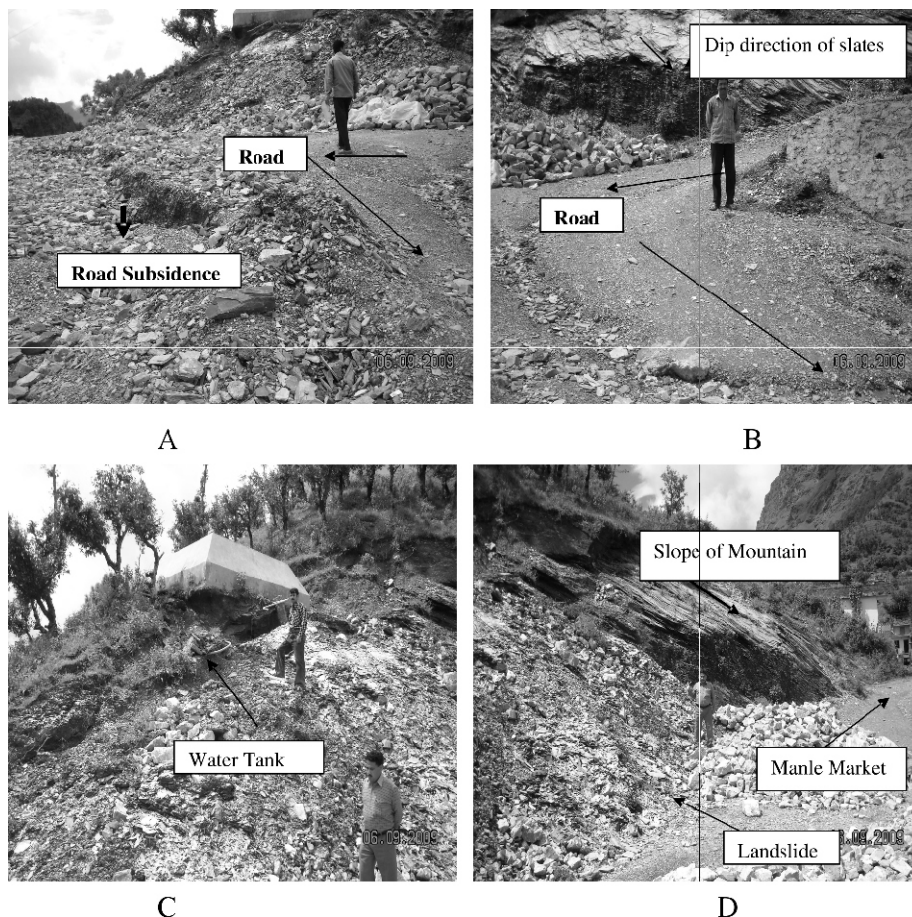
**Fig.-2** A. Showing Landslides and Road subsidence B. Dip Direction of the rock and mountain slope are similar C. Rock material and soil at the base of water tank moved downwards D. Showing Landslides at the HP Bend.

There is no proper drainage system towards the road side. Due to this the pore pressure increases in undrained soil layers beneath the road at the eastern side of the H P Bend and subside nearly  $1\frac{1}{2}$  feet (Fig. 2A). For small scale landslides under laboratory condition, Sassa and Takei,

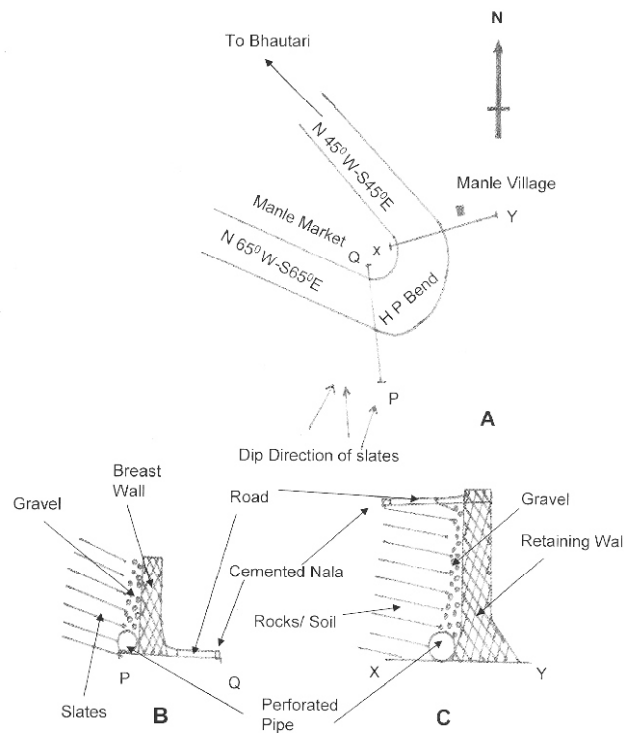
**Fig. - 3 A.** Showing orientation of roads before and after HP Bend, B & C. Process of Road Construction

(Fig. 3B) towards the southern side of H P Bend breast wall should be prepared at the foot of the slope of the hill. Width of the wall must be large enough to make it stable and there should be adequate provisions for draining out water lodged inside the soil or rocks through weep holes or pipes in order to relieve with build up of pore pressures. At the base between hill and breast wall horizontal drains should be made using porous or perforated pipes. If required this horizontal drains may be used in combination with vertical drainage shafts or wells. The gravel mass filled

behind the breast wall allows accumulation of underground water without causing build up of water pressure. Cemented nala (side drain) should also be prepared towards the core side of the H P Bend so that surface water should be properly drained. (b) At X-Y section (Fig. 3C) towards eastern side of the H P Bend i.e. towards Manle village side, the retaining wall is prepared up to the firm beds provide support at the toe. Since a retaining wall has to withstand tremendous and unequal pressures and load, the width must be large enough to make it stable. Other things are similar as the P-Q section. (c) At the Bend the road surface should be cemented.
