Landslide Studies Between Devprayag and Pali along National Highway-7, Tehri District, Garhwal Lesser Himalaya

R.A. Singh^{*1}, Rahul Negi², Piyush K. Singh³, and T.N. Singh⁴

Index Terms: Active Landslides, Damage zone, Mitigation, NH-7, Potential Landslides.

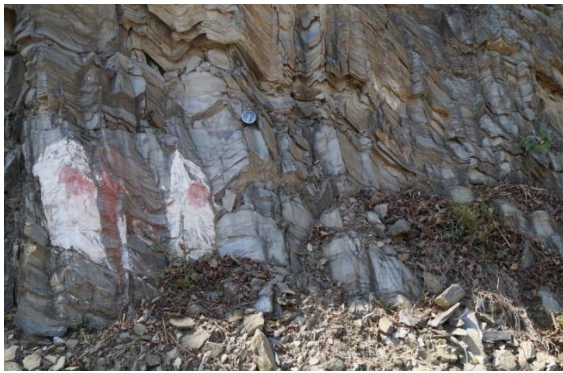
Fig. 4. Crenulation cleavages in phyllite.

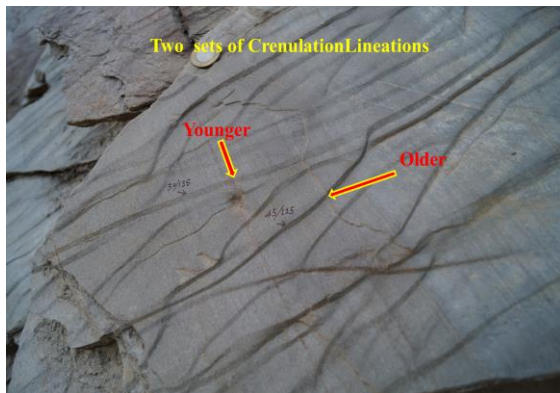
Fig.5. Crenulation lineations in phyllite.

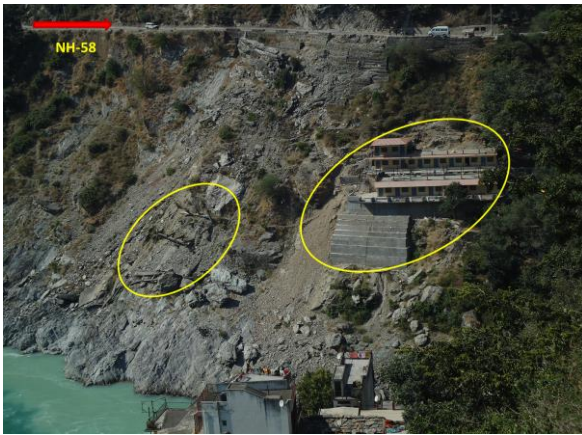
This landslide is present at $N30^{\circ} 08' 44.77''$ & $E78^{\circ} 35' 47.60''$ and an altitude of 517m, just above the confluence of Alaknanda and Bhagirathi Rivers (Fig. 8 & 9). The length and width of this landslide is 85 m and 54 m, respectively. This landslide reactivated during June 2013. This landslide is present on steep slope and the nature of this landslide is at places concave and at places planer. This is the complex type of landslide and contains boulders of about $4\text{ m} \times 2\text{ m}$ in size. Causes of this landslide are rainfall, joints, slope, toe cutting and weathered materials.

Fig.8. House present in danger condition in middle right part of the photograph and foundation of another house damaged in middle left of the photograph due to L_1 landslide.

For safety measure gravity retaining wall and gabion retaining wall are present. Netting, cementing and anchor hold mitigation methods are used for this landslide. Rest house of Badrinath and Kedamath Mandir Samiti is in danger condition because it is subsiding and cracks are also developed in the floor. Base rock around this landslide is Phyllite.

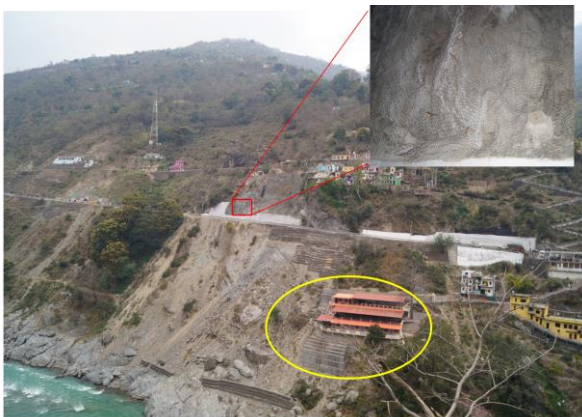
Fig. 9. Photograph shows L_1 landslide after treatment in 2018. A house marked by ellipse is still subsiding.

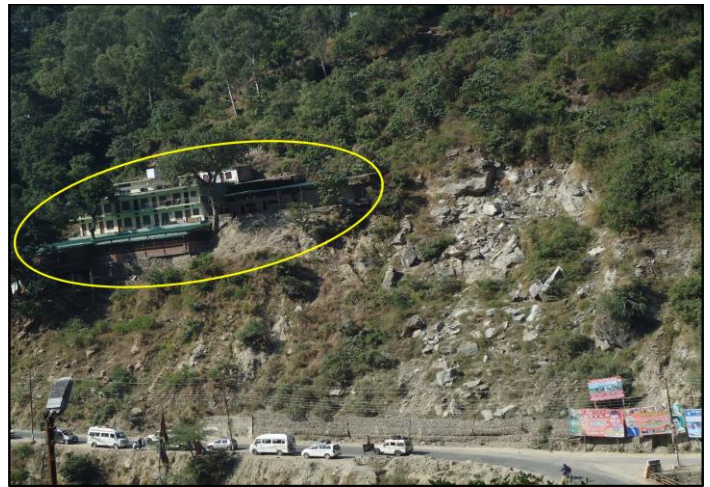
This landslide is present at $N30^{\circ} 09'01.37''$ & $E78^{\circ} 35'51.85''$ and an altitude of 498 m, just before the bridge of Devprayag (Fig.10). The length and width of this landslide is 26 m and 106 m, respectively. This is the old landslide which faces in eastern direction. The slope of this landslide is steep and the nature of the failure is concave. This is a rock fall and debris types of landslide containing boulders of up to $5\text{ m} \times 3.5\text{ m}$ in size. The rock present around this landslide is Phyllite. Causes of this landslide are heavy rainfall, base cutting of slope for road widening, rock slope, joint and weathered materials. A house present is in danger condition by the impact of this landslide. Supporting wirecated wall is also present in the bulged condition.

Fig. 10. House present is in danger condition due to L_2 landslide.

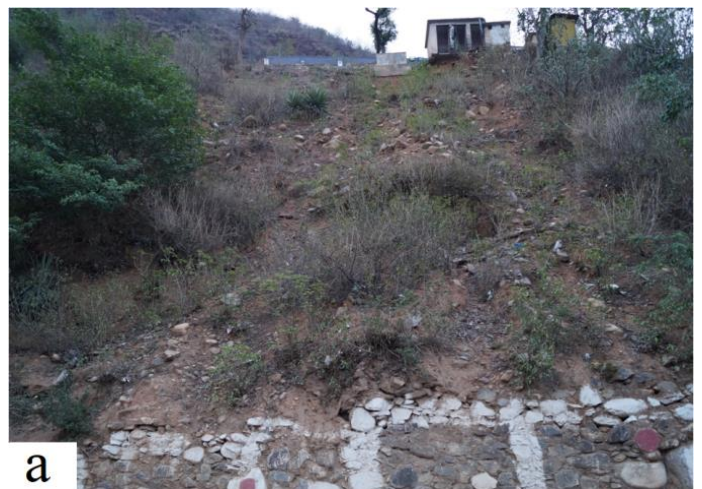
This landslide is located at $N30^{\circ} 08'47.95''$ & $E78^{\circ} 35' 56.60''$ and an altitude of 539 m just after 1 km from Devprayag along NH-7 (Fig. 11 a & 11 b). The Length and width of this landslide is 20 m and 60 m, respectively. This is an old landslide which facing in western direction. The Slope of a landslide is steep and the nature of the failure is concave. This is debris and soil creep types of landslide containing river boulders up to $32\text{ cm} \times 20\text{ cm}$ in size. Phyllite and river boulders are present around the landslide. Causes of this landslide are rainfall, road cutting and loose materials. Due to this landslide, the materials below the foundation of toilet, Government Girls Inter College (GGIC)Devprayag is eroding and the toilet may fall in the future if proper treatment will not be done. Cactus has been planted on the landslide for stability and stairs are also made from road to GGIC in 2018. This is a potential landslide and may activate in the future.

Fig.11 a. Photograph shows that the materials below the foundation of toilet, GGIC, Devprayag has eroded due to L_3 landslide.

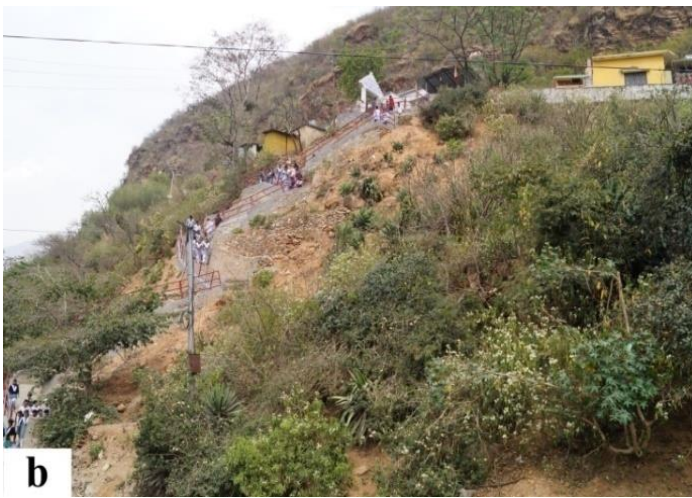
Fig.11 b. At places plantation of Rambans (cactus) has been done for landslide treatment.

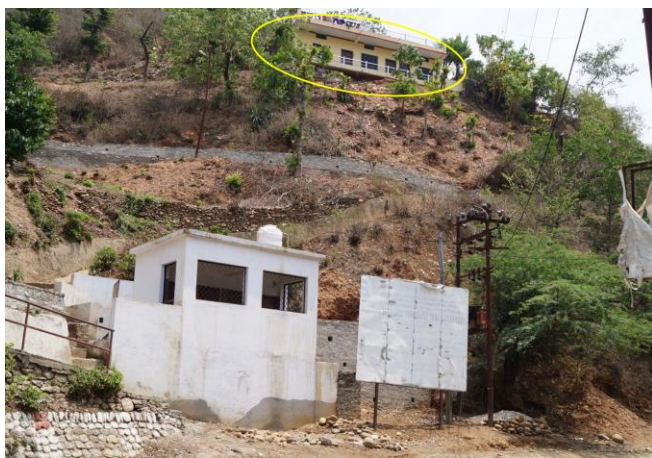
This landslide is present at N30° 08' 43.92" & E78° 36' 9.36" and an altitude of 552 m along NH-7 (Fig. 12). The length and width of this landslide is 42 m and 40 m, respectively. This is an old landslide and present on the steep slope. This is debris and soil creep types of landslide containing boulders up to 20 cm × 30 cm in size. Phyllite rock and river bed materials present around this landslide. Causes of this landslide are rainfall, loose materials (soil & river bed material) and base cutting of slope for road widening. Due to this landslide foundation of the building is removed under the action of gravity and house owner kept wood and sand fill bags for safety measure. This is also under potential landslide. This landslide may activate in the future and damaged the house.

Fig. 12. In this photograph material below the house has moved down due to L₄ landslide and house is in danger condition. House is marked by ellipse.

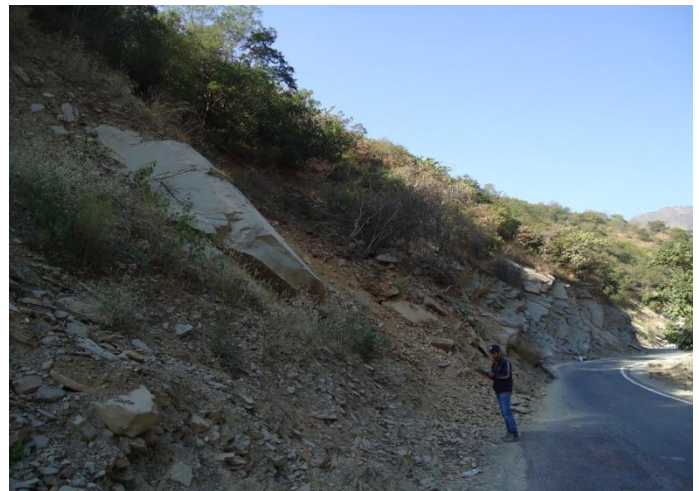
This landslide is present at N30° 09' 51.45" & E78° 37' 1.62" and an altitude of 578 m along NH-7 (Fig.13). The length and width of this landslide is 30 m and 70 m, respectively. This landslide is reactivated after road widening and heavy rainfall during 2018. The slope of failure is steep. This is debris slide type of landslide containing boulders up to 2 m × 3 m in size. Phyllite is present around the landslide. Causes of this landslide are rainfall, rock slope, base cutting of slope for road widening and gravity.

Fig. 13. Photograph shows debris slide of L₅ landslide.
