Engineering Geophysical Investigation of Oka-Isua-Ibillo Highway Failure; Remedy and Road Sustainability in Nigeria

Ademila, Omowumi

Abstract: Oka-Isua-Ibillo highway in southwestern Nigeria has been in bad condition despite several rehabilitation and reconstruction works. Thus, Very low frequency electromagnetic (VLF-EM) and electrical resistivity methods adopting fifty-one Schlumberger sounding locations using vertical electrical sounding (VES) technique and 2-D geoelectrical resistivity imaging utilizing dipole-dipole array were conducted along some unstable and stable sections of the road, to characterize the subsurface geological condition and causes of its persistent failure. VLF-EM 2-D models and resistivity sections of the subsurface profiles revealed existence of near-surface structures and four distinct lithologic units in suspected structurally weak zones. The varying trends and geometry of structural features are indication of structural instability of the underlying rocks. The road pavement is constructed on deep weathering bedrock of low resistive ($< 100 \Omega\text{m}$) water saturated clayey subgrade which caused its failure. Uneven bedrock topography coupled wit

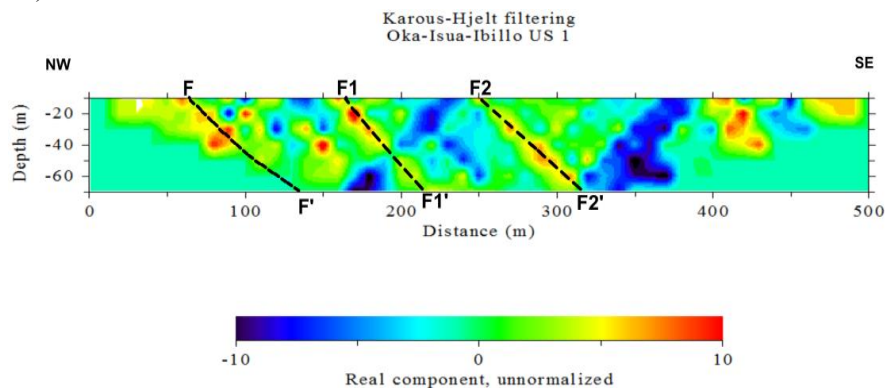
Geological features with different range of high conductivity are detected on failed section 1 at distances 20 – 200 m, 270 – 310 m and 400 – 500 m (Fig. 2). These suspected linear features of different conductivity ranges in different azimuthal directions are indicative of weak zones of clayey overburden, fractures/faults and aquiferous zone on which the road pavement is constructed. They are indicative of incompetent geologic formation which could lead to instability of the road pavement. The 2-D resistivity structure displayed low resistivity (< 100 Ωm) across the section above 20 m

Fig. 2. VLF-EM 2-D inverted model along Road Section 1

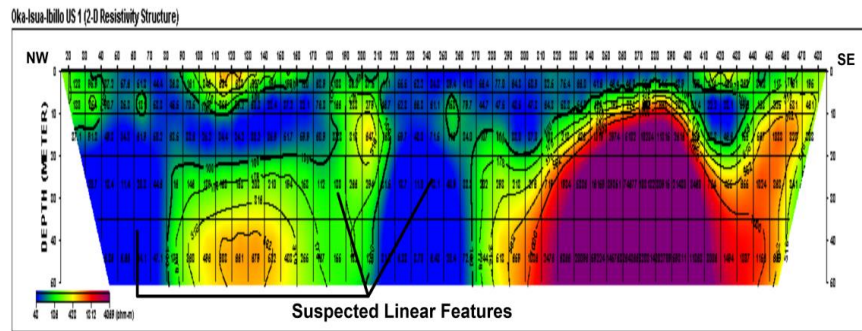
depth (Fig. 3). The weathered zone is an indication of water absorbing clay. It identifies linear features of about 20 m which characterized subsurface structures; fault/fractures, lithological contacts or water bearing formation at distance 20 – 280 m. A low resistive portion at the depth between 5 – 15 m specifies clay composition on 2-D structure at distance 40 – 180 m and 210 – 310 m, correlates with weathered layer on the geoelectric section. Also, the linear features on the 2-D subsurface resistivity structure correlate the result from VLF-EM section. Four subsurface layers are delineated at this location (Fig. 4). The topsoil and weathered layer (subsoil) at the depth between 0 – 6 m are largely composed of clay (resistivity values < 150 Ωm) with sandy clay and clayey sand in place as topsoil beneath VES stations 1, 5 and 6 with resistivity values < 200 Ωm (Fig. 4). The clay composition of the weathered layer with < 100 Ωm indicates water saturated zone. This clay composition and water saturation of the subsoil are responsible for observed highway pavement failure. Also, the closeness of the weathered layer which constitutes the aquiferous zone to the surface in some locations of the road section poses threat to the stability of the highway. This suggests that the highway structure is constructed on incompetent/weak subgrade which accounts for the continuous failure along the road even shortly after maintenance and reconstruction works. The basement topography is irregular and forms depression at VES station 3 with depth to bedrock from 10.2 – 29.7 m (Fig. 4). Highway pavement failure at this locality is as a result of incompetent clayey subsoil, near-surface and subsurface linear features.

Fig. 3. 2-D resistivity image of the subsurface from dipole-dipole resistivity survey along Road Section 1

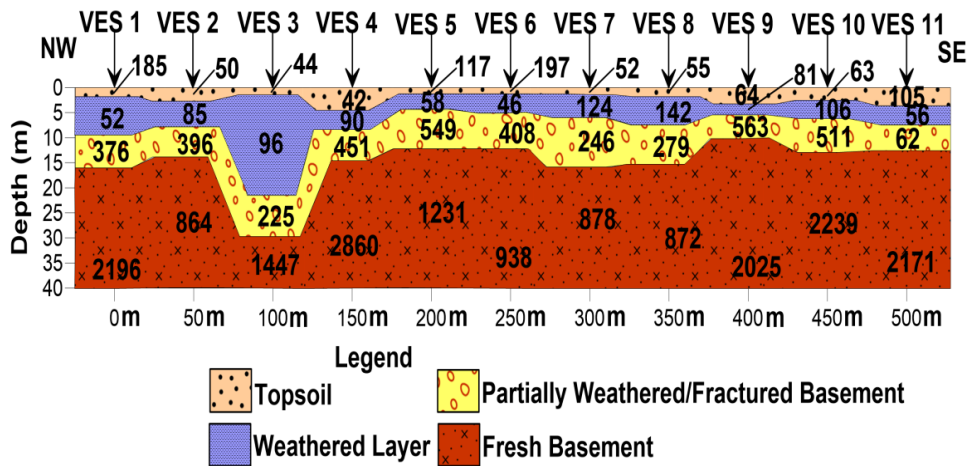
Fig. 4. Geological section obtained from interpretation of VES curves 1 to 11 along Road Section 1

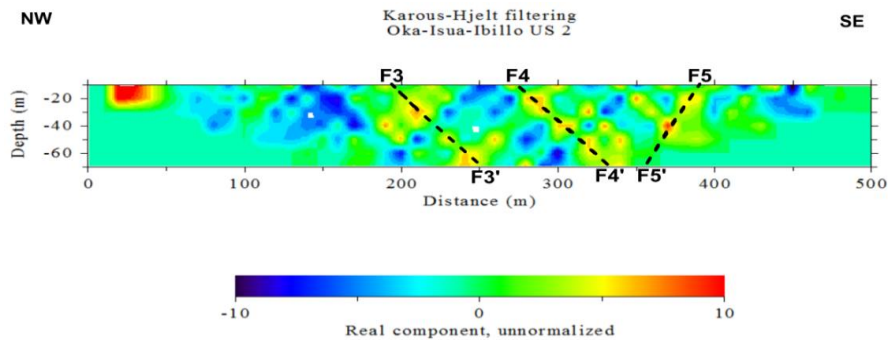
Conductive bodies traversing between stations 10 – 50 m and 190 – 400 m on VLF-EM section indicate near-surface structures such as fractures, lineaments, lithological contact, shear zones, or clay bodies (Fig. 5). The presence of conductive zones at different points is indicative of incompetent layer across the road section. The conductive zones are typical of linear features (fractures) which coincide with the suspected fractures on the 2-D resistivity structure (Fig. 6). These are characteristic zones of weakness responsible for structural instability in a basement terrain. The 2-D resistivity structure majorly shows low resistive zones (< 100 Ωm) at several locations signifying the presence of water absorbing clay (Fig. 6). These low resistive zones indicate high saturated region and poor engineering geomaterials exhibited in the area. Low resistive structures, characteristics of fault/fracture/aquiferous zones are observed on the 2-D resistivity structure at distance between 60 – 130 m, 150 – 260 m and 310 – 360 m at the depth above 30 m (Fig. 6). They fall within intensively fractured basement on the geoelectric

Fig. 5. VLF-EM 2-D inverted model along Road Section 2

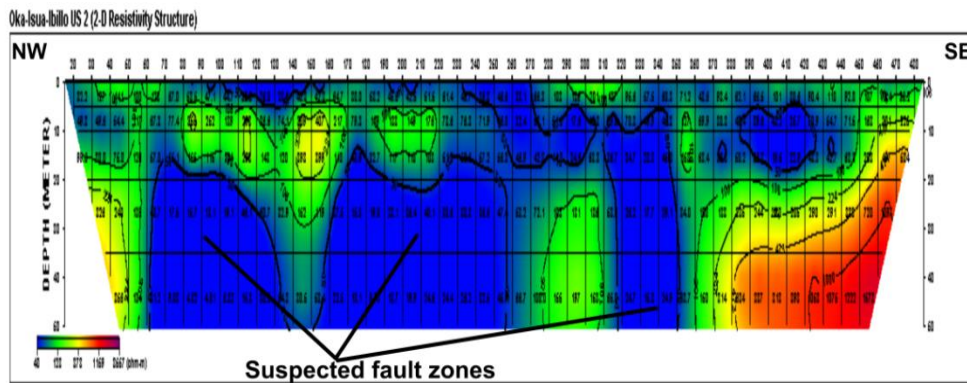
section and fairly high conductivity region on the 2-D VLF-EM model. The low resistivity values generally (< 60 Ωm) indicate the presence of clay enriched water absorbing substratum. It also identifies near vertical/vertical low resistivity features having significant depth extent (> 40 m) typical of faults/fractures, aquiferous zones/buried stream channels at surface distance expression of 150 – 200 m. The presence of water saturated clayey substratum and vertical discontinuity may have been responsible to extremely failed section of the road pavement. Four different lithologic units were established. The resistivity values of subgrade vary between 31 – 207 Ωm corresponding to clayey composition, and thickness which varies between 0.6 – 6.9 m. The subsoil is majorly composed of clay (resistivity values from 51 - 109 Ωm) except beneath VES station 15 with resistivity value of 157 Ωm indicating clayey sand nature of the soil. The third layer is partially weathered/fractured basement with resistivity values that vary from 126 – 521 Ωm beneath the VES stations (Fig. 7). These resistivity values correspond to water-bearing unit/aquiferous zone beneath the subsurface that contribute to

the failure of the road pavement observed in the area. The presence of this layer constitutes weak zones that facilitate failure of the highway pavement. The bedrock topography is undulating with pronounced depression observed at sounding

Fig. 6. 2-D resistivity image of the subsurface from dipole-dipole resistivity survey along Road Section 2

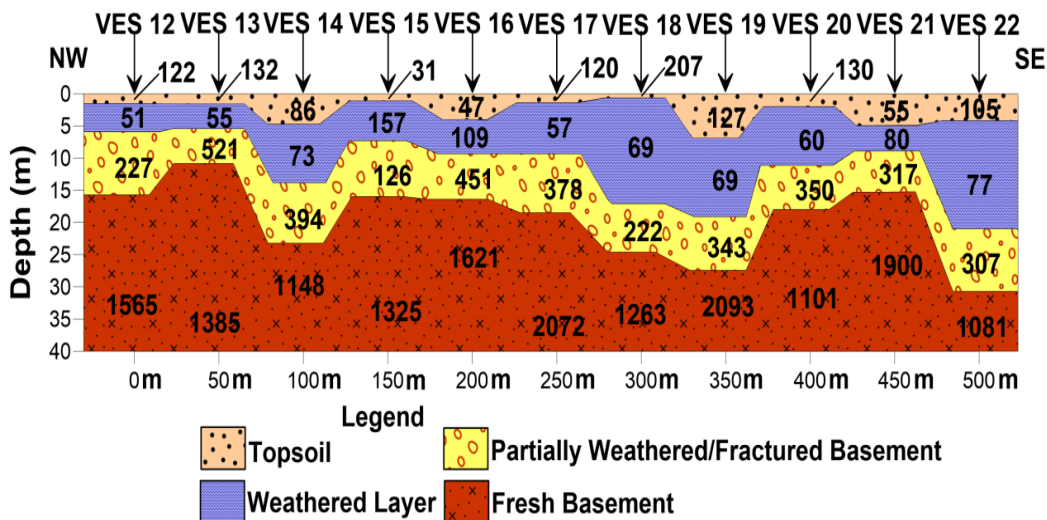
stations 14, 18, 19 and 22. Depth to basement varies from 10.8 – 30.7 m (Fig. 7). Clayey nature of the subsoil (both topsoil and regolith) and bedrock depression are the reasons for the highway failure.

Fig. 7. Geological section obtained from interpretation of VES curves 12 to 22 along Road Section 2

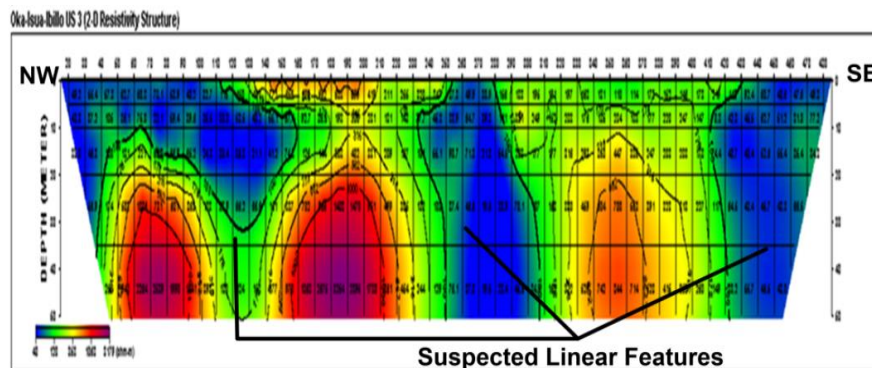
Fig. 9. 2-D resistivity image of the subsurface from dipole-dipole resistivity survey along Road Section 3

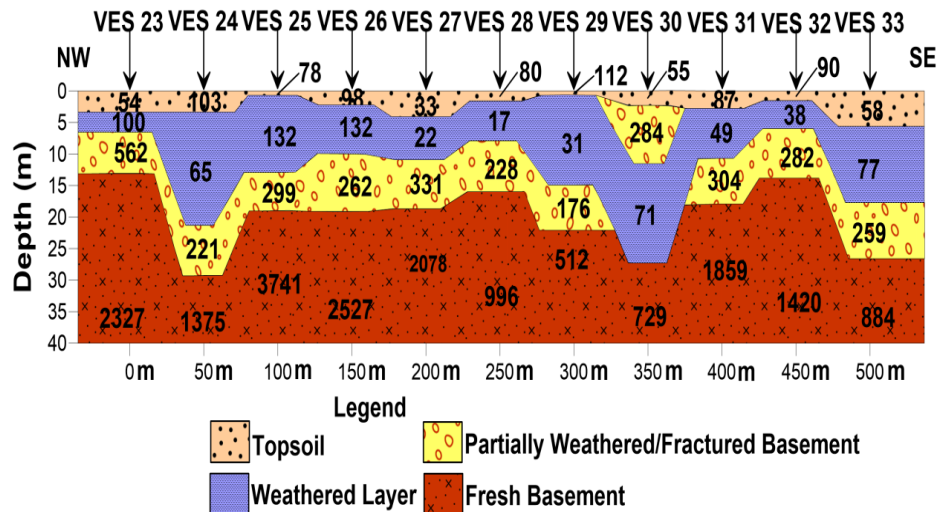
Ωm (Fig. 10), makes it an incompetent construction soil that poses threat to integrity/strength of highway pavements. Resistivity values of this layer is an indication of very high level of saturation corresponding to the aquiferous zone in the area, suggesting the reason the section of the road is extremely bad. Water absorbing clay composition of the subsoil from the geoelectric section accounts for the exceptionally bad portion of the road with possibly high moisture content. The closeness of fractured basement to the surface beneath VES station 30 also precipitated the failure of the road pavement in the area as it corresponds to water-bearing unit beneath the subsurface. The bedrock topography is uneven, forms depression at VES points 24, 29, 30 and 33 with depth to bedrock varying from 13.1 – 29.3 m. This basement depression also threatens the strength of the highway structure. Instability of road pavement at this locality may have been as a result of incompetent clayey subsoil, near-surface and subsurface structures; fracture, aquiferous zone, shear zones or lithological contacts. These geologic features serve to enhance water storage, causing reduction of strength of subsoil with resultant road pavement failure.

Fig. 10. Geological section obtained from interpretation of VES curves 23 to 33 along Road Section 3

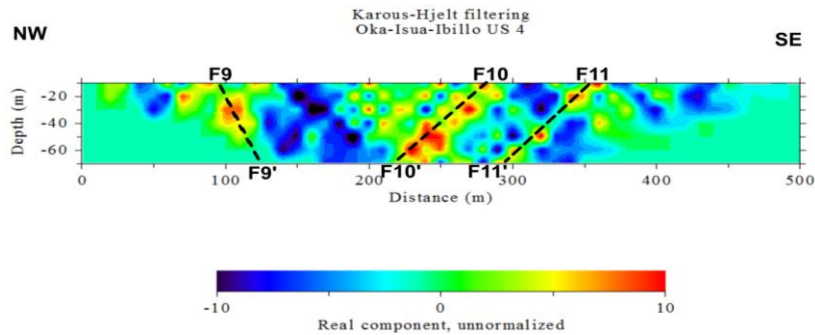
The same process of interpretation was adopted for the remaining VLF-EM 2-D inverted models, 2-D resistivity images of the subsurface from dipole-dipole resistivity survey and the geological sections obtained from interpretation of VES curves 34 to 44 and 45 to 51 along Road Sections 4 and 5. Linear features of high conductivity are displayed on the 2-D VLF-EM section at distance 20 – 125 m and 200 – 430 m which are fault/fracture, aquiferous zone or lithological contacts (Fig. 13). The inverted section along this Road section 4 depicts an uneven subsurface topography reflecting different degree of conductivities. The observed conductive linear features at this location suggest conductive materials at depth, indicating the presence of fractures and basement depressions constituting water collection zones and saturated clay which are unsuitable to sustain road pavement. The Identified conductive bodies correspond to the conductive zones delineated as fractured zones, which are engineering incompetent zones that would pose significant threat to structural foundation of road construction works in the study area (Fig. 13). Thus, it has to be taken into consideration in road design and construction to enhance durable roads. The presence of these structures indicate unsuitable geologic unit on the highway section. The 2-D resistivity structure displayed low resistive geomaterials below 100 Ω m at distance 20 – 130m, 220 – 310 m and 360 – 410 m above 30 m of depth

Fig. 13. VLF-EM 2-D inverted model along Road Section 4

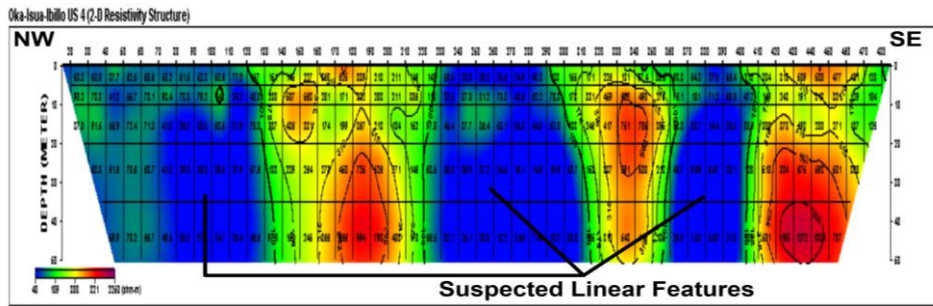
(Fig. 14). This is an indication of saturated clay layer. It however identifies linear features; lithological contacts and water bearing units. The suspected linear features on the 2-D resistivity structure (Fig. 14) also fall within fractured layer on the geoelectrical section. Four subsurface units are likewise delineated (Fig. 15). The low resistive topsoil layer of 21 - 86 Ω m, typically clay with thickness varying from 1.0 – 5.1 m attributed to weak zones responsible for instability of the road pavement. The weathered formation has resistivity values ranging from 24 – 123 Ω m with thickness 5.2 – 15.6 m. The clay composition and water saturation of the subgrade constitute the observed highway pavement failure. There is an indication of high degree of saturation corresponds to the aquiferous zone in the area. This suggests that the road pavement is constructed on incompetent water absorbing geologic layer which accounts for the continuous failure along the road even shortly after maintenance and reconstruction works. The partially weathered/fractured basement has resistivity values varying from 200 – 422 Ω m. The resistivity relates to aquiferous zone beneath subsurface as this also contributes to the highway failure in the location. Bedrock topography is uneven and its depth in the range 14.1 – 29.0 m (Fig. 15). The bedrock forms depression between VES stations 35 – 36 and 42 – 43. Highway pavement failure at this locality is as a result of incompetent clayey subsoil, basement depression, near-surface and subsurface linear features.

Fig. 14. 2-D resistivity image of the subsurface from dipole-dipole resistivity survey along Road Section 4

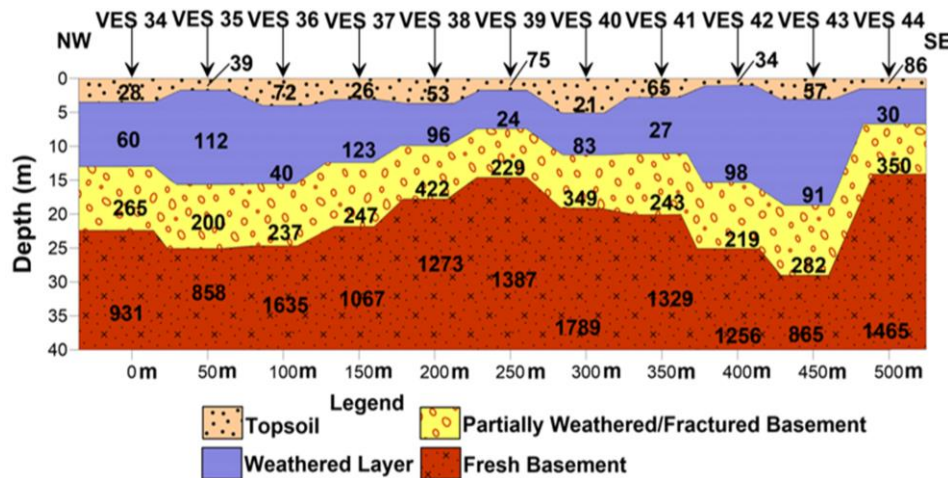
Fig. 15. Geological section obtained from interpretation of VES curves 34 to 44 along Road Section 4
